PRODUCT UPDATE CAMPAIGN

2021 SXS1000M/1000S - BRAKE DISC BOLT TORQUE INSPECTION

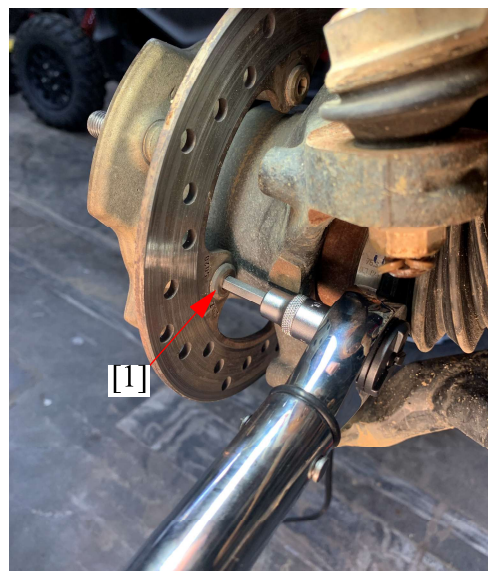
1. Safely position the vehicle on a lift.
2. Remove all four (4) wheels.
3. Rotate the front hub and visually confirm that all four (4) front brake disc bolts are seated to the brake disc.
 - If all brake disc bolts are seated to the brake disc, confirm torque [1] **42 N·m (30 lbf·ft)**.
 - If one (1) or more brake disc bolts are not seated, see repair section of this bulletin.

1. If one (1) or more front brake disc bolts are not seated to the brake disc, remove all four (4) brake disc bolts and replace with NEW bolts.

- Seat bolts and torque to **42 N·m (30 lbf·ft)**.

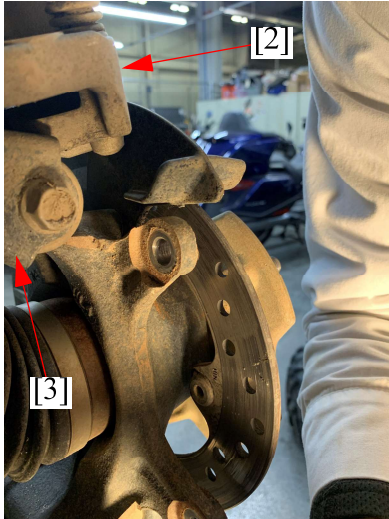
5. Remove rear brake caliper [2] and place on the A-arm[3], to prevent the brake caliper from hanging from the brake line.

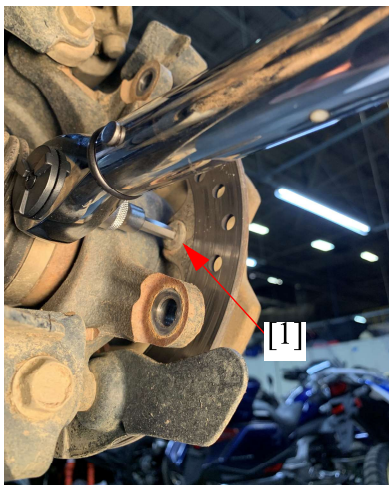
6. Rotate the rear hub and visually confirm that all four (4) brake disc bolts are seated to the brake disc.

- If all brake disc bolts are seated to the brake disc, confirm torque [1] **42 N·m (30 lbf·ft)**.
- If one (1) or more brake disc bolts are not seated, see repair section of this bulletin.

4. If one (1) or more rear brake disc bolts are not seated to the brake disc, remove all four (4) brake disc bolts and replace with NEW bolts.

- Seat bolts and torque to **42 N·m (30 lbf·ft)**.

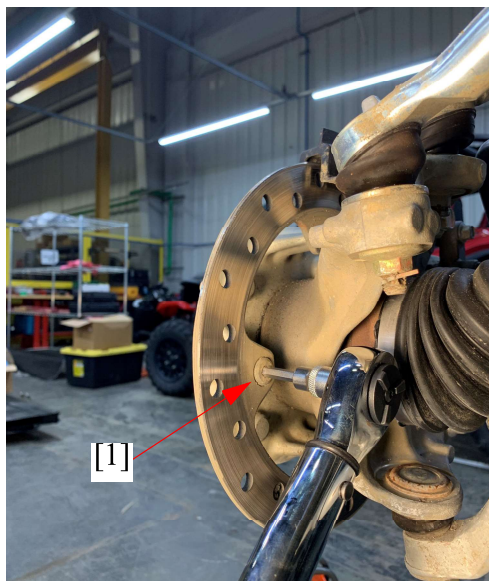
1. Safely position the vehicle on a lift.
2. Remove all four (4) wheels.
3. Rotate the front hub and visually confirm that all four (4) front brake disc bolts are seated to the brake disc.
 - If all brake disc bolts are seated to the brake disc, confirm torque [1] **42 N·m (30 lbf·ft)**.
 - If one (1) or more brake disc bolts are not seated, see repair section of this bulletin.

1. If one (1) or more front brake disc bolts are not seated to the brake disc, remove all four (4) brake disc bolts and replace with NEW bolts.

- Seat bolts and torque to **42 N·m (30 lbf·ft)**.

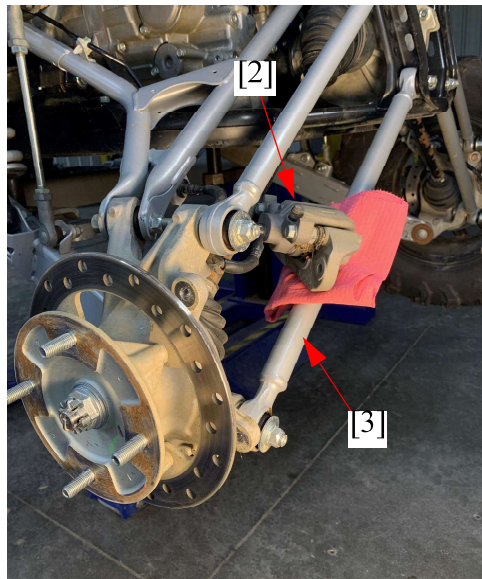
5. Remove rear brake caliper [2] and place on the lower rear link [3], to prevent the brake caliper from hanging from the brake line.

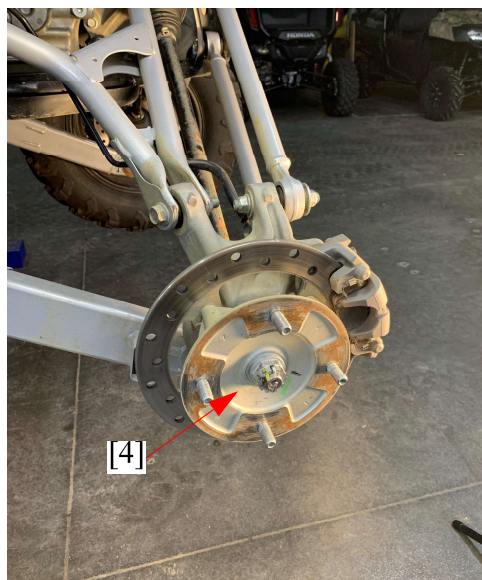
6. Remove the rear hubs [4]

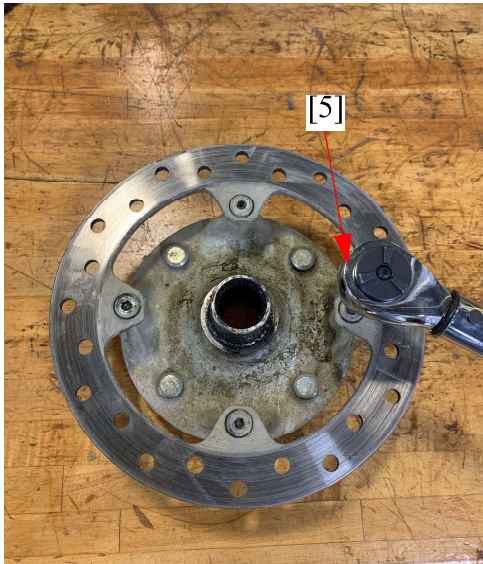
7. If all brake disc bolts are seated to the brake disc, confirm torque [5] **42 N·m (30 lbf·ft)**.

- If one (1) or more brake disc bolts are not seated, see repair section of this bulletin.

3. If one (1) of more rear brake disc bolts are not seated to the brake disc, remove all four (4) brake disc bolts and replace with NEW bolts.

- Seat bolts and torque to **42 N·m (30 lbf·ft)**.
