2016-2017 SXS1000M (Pioneer) Clutch Slipping Common Issues - Repair Tips

This Special Edition of *The Wrench* includes tips to help reduce common issues when performing Service Bulletin SXS1000 #3 - Product Improvement Campaign for Clutch Slipping on 2016-2017 SXS1000M (Pioneer) series vehicles. Be sure to review SXS1000 #3 and the information in this document, including the linked video, before performing this repair.

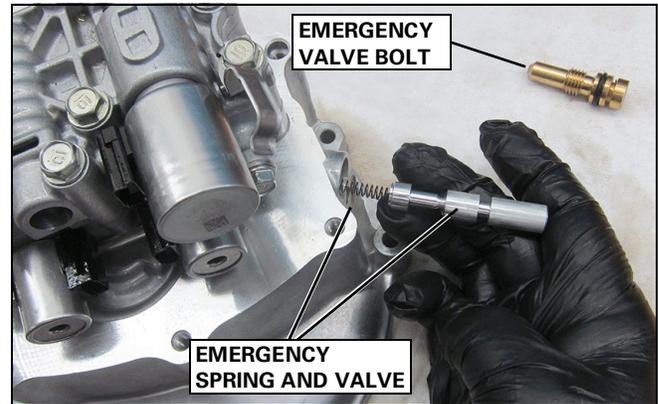
EMERGENCY VALVE

Symptoms: Oil light on, stalls when shifted into gear, will not initialize, no drive

Cause: Incorrect installation of the emergency valve.

Troubleshooting: Check if emergency valve is bent from over torquing of the emergency bolt by rolling it on a flat surface. Be sure there are no burrs or other damage before installing.

- Check for damage (bent, burrs, etc.) and smooth operation.

- The top surface of the emergency valve is flat and the bottom surface is cupped for spring seating (install as shown).

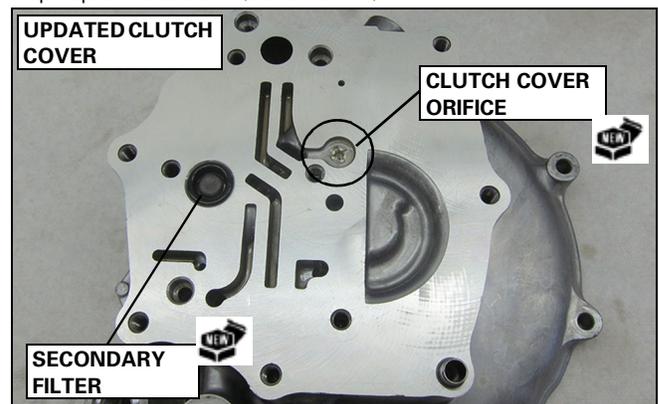
CLUTCH COVER ORIFICE

Symptoms: Possible low oil pressure, oil light on when hot, may not initialize

Causes: Orifice not installed in new cover, orifice installed in wrong place

- Be sure the orifice is installed correctly.

- Be sure the orifice is installed correctly, in its proper location (as shown).

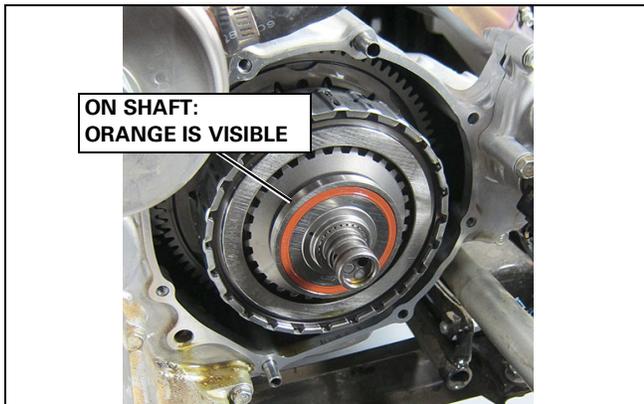
Symptoms: Clutch slip, possible harsh engagement, no drive

Causes: Clutch cover/shaft bearing installed backwards damaging both clutches due to lack of lubrication.

Troubleshooting: Be sure the clutch cover/shaft bearing is installed correctly.

- If the bearing is on the shaft, be sure the orange colored (sealed) side is visible (as shown).

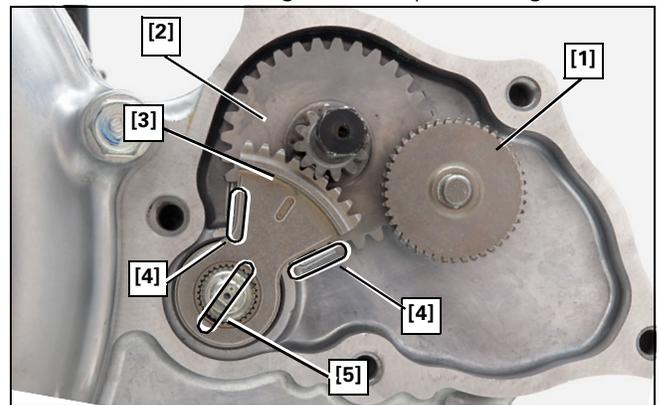
SHIFT REDUCTION GEAR

Symptoms: Difficult/no shift, DTC 57-1

Cause: Shift reduction gear installed backwards.

Troubleshooting: Be sure gears are installed with marks facing out and move freely without binding.

Repair Tips: Install gears with marks facing out (as shown) and as described below.

1. Install reduction gears [1]/[2].
2. Install gear [3] onto the shaft spindle by aligning the wide groove with the wide tooth.
3. Make sure the gear ends align with the lugs [4] on the rear cover spacer and the punch marks [5] on the gear and spindle align.

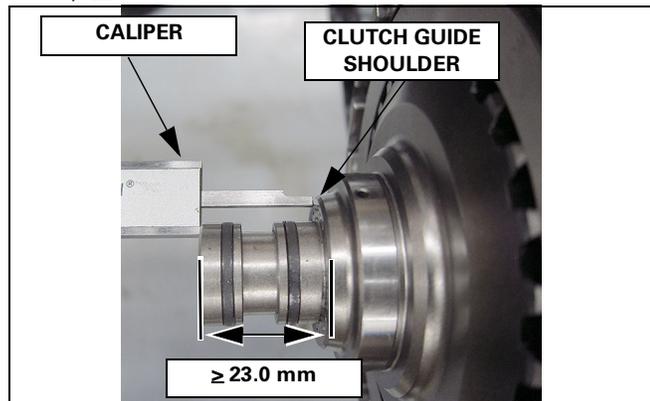
CLUTCH PLATES / GUIDE COLLAR

Symptoms: Stalls in gear, will not initialize, no drive, possible difficult/no shift

Cause: Clutch guide collar not aligned or fully seated causing clutch plate damage during cover installation.

Troubleshooting: Check clutch guide for proper seating. Watch the linked video below or you can access the video by navigating to:

Repair Tips: Replace clutch assembly

- Be sure the clutch cover is fully seated against the gasket surface before tightening the cover bolts.

Verify ≥ 23.0 mm measurement (as shown).
