Service Bulletin

Multiple Model: SXS/TRX #1

2019-2020 SXS500/700/1000, TRX420/500/520 FUEL PUMP (PIONEER, TALON, RANCHER, FOREMAN, FOREMAN RUBICON)

(This bulletin has been revised to correct the parts information for the Talon S4)

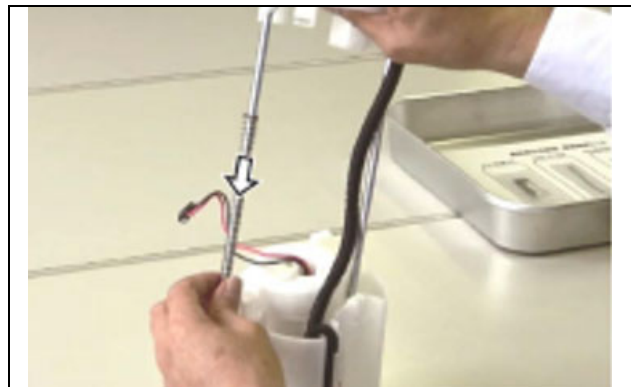
9. Pull out the sliding shaft then remove the spring.

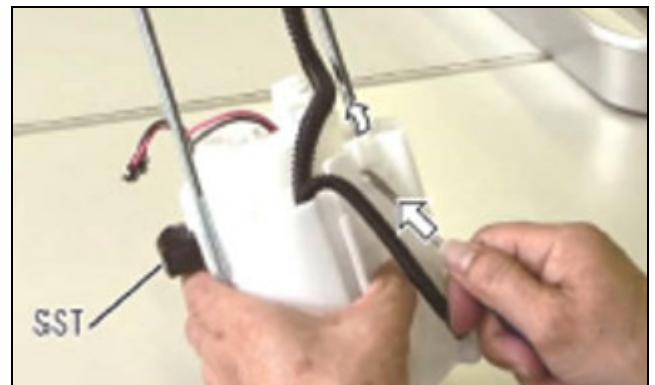
13. With the two lock tabs released, use a screwdriver to remove the remaining lock tab.

NOTICE: Be careful to not spread the lock tab too wide or it may be damaged.

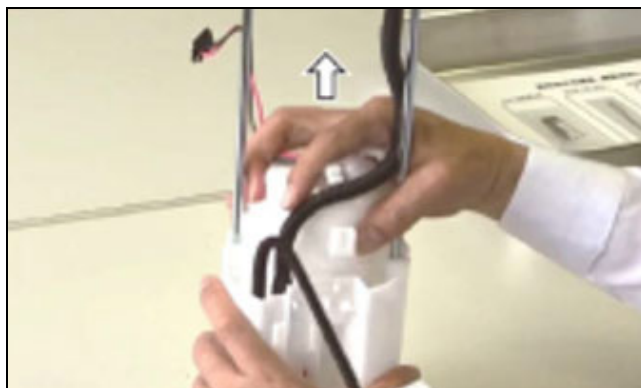
14. Pull out the strainer from the reservoir.

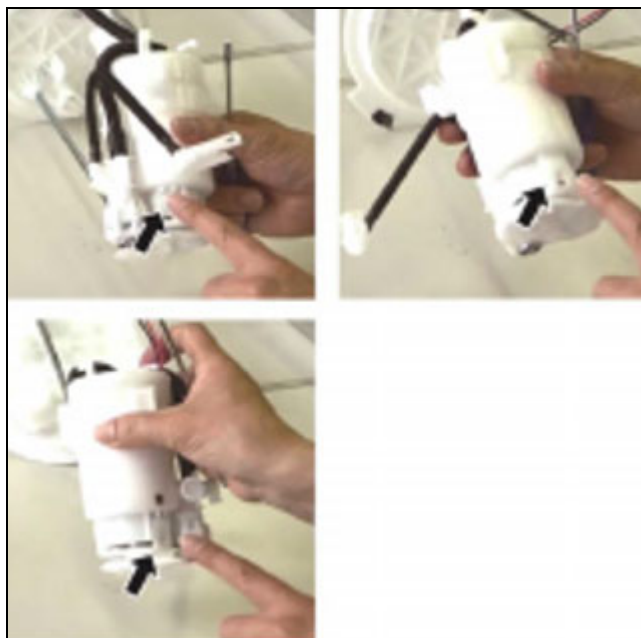
15. Remove the fuel pump by releasing the three lock tabs in the locations shown.

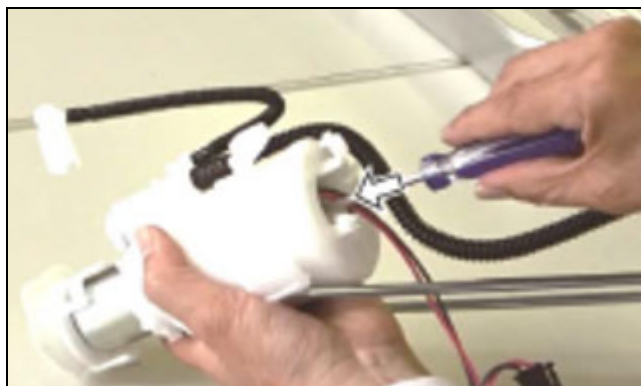
16. If necessary, use a tool to push out the fuel pump.

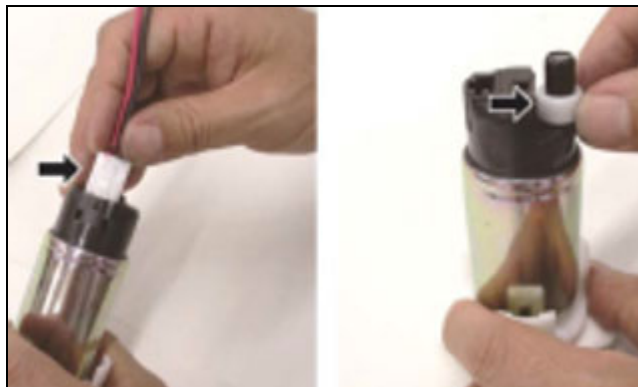
17. Remove the wire harness and spacer from the fuel pump.

NOTE: The fuel pump, wire harness, and spacer cannot be reused. Be sure to mark these parts with permanent marker to avoid accidentally reinstalling these parts.

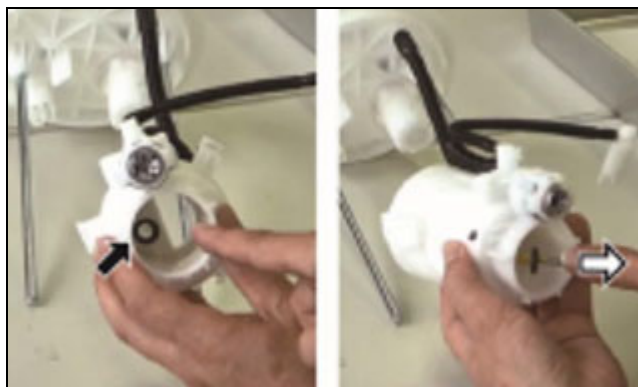
18. If the o-ring remains on the strainer, use a flathead screwdriver wrapped in protective tape to remove the o-ring to avoid damaging the o-ring seat.

NOTE: If this o-ring is not removed, and double o-rings are installed, the vehicle will not operate correctly. The o-ring should be immediately cut to avoid accidentally being reused.

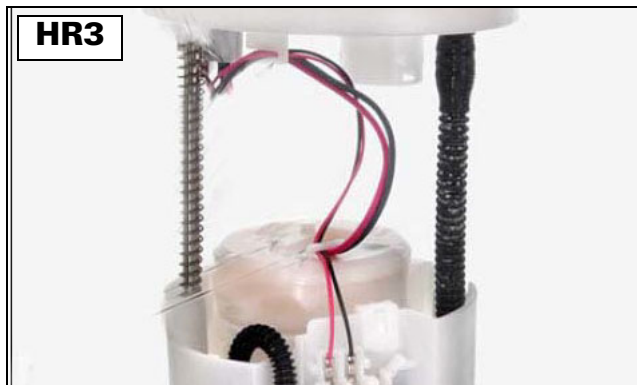
25. Install the upper fuel tube into the clamps (HL3 only).

NOTICE: Be careful not to damage the fuel tube.

NOTE: The HL3 and HR3 vehicles have different routing for the upper fuel tube. Refer to the appropriate image below.
